**TRUSTED LEADERS IN
INNOVATIVE ROOF
COATINGS
SINCE 1978.**

The Commercial Roofing Resurfacing & Restoration Marketing includes:

Metal Roof Restoration

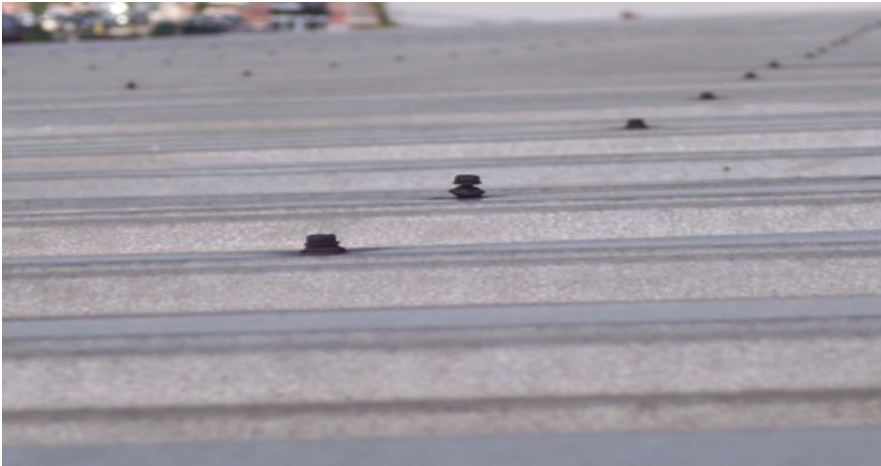
The first issue to observe is the condition of the mechanical attachment of the panels. Examine the roof for loose or missing fasteners that have no seal or seals/mastic that are broken, cracked or in a phase of disintegration.

Over the course of time the first place that water will infiltrate a metal roof is at the fasteners.

In this particular metal roof design, the fasteners at the horizontal seam also hold down a metal strap.

If the repair contractor is unfamiliar with this design, they will often use materials that do NOT allow the free flow of water through the strap, therefore trapping water at the seam and creating a new problem while attempting to remedy an existing one.

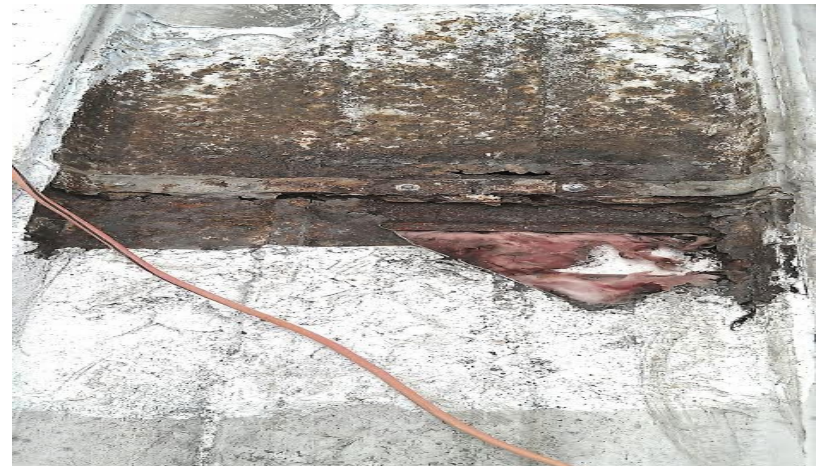
A typical field condition found at horizontal seams

In many instances, as just observed in the previous slide, the horizontal seam at the ends of the overlay of the panels exhibit excessive rust. This is normally caused by either poor repair techniques or simply aging of the metal roof.

On low slope metal roofs, 2:12 or less that utilize bar straps is frequently found that repair materials have been applied that block the flow of water that has been engineered into the bar strap design.

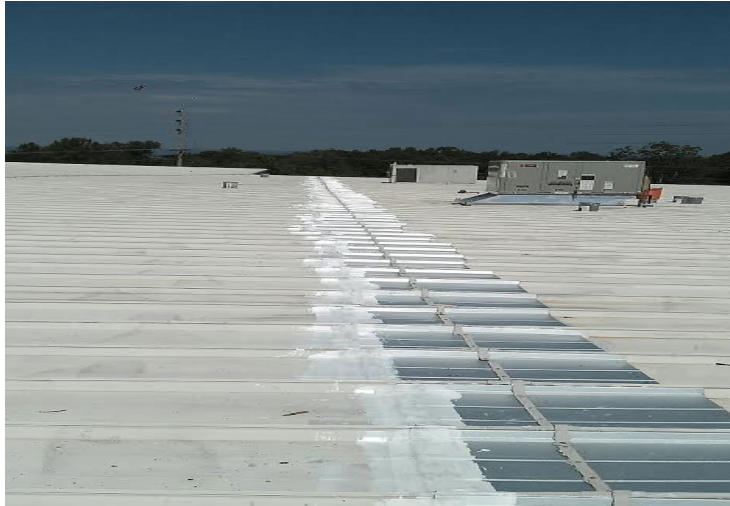
If left too long, the end of the metal panel cannot be preserved and replacement of this metal design element is necessary as shown here.

Low slope metal roof repair

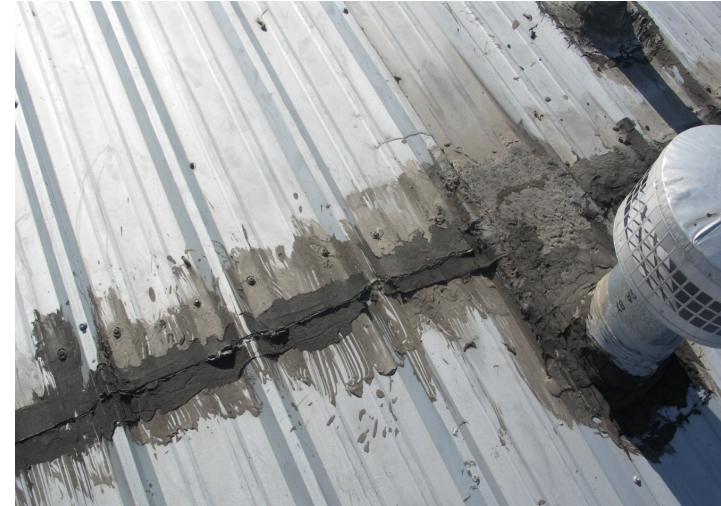
In almost every case existing repairs are removed before any permanent repairs or restoration work begins.

First, in many instances, the material used was not designed for the extreme environment of metal roofing.

Second, even if the material is one designed for this purpose, the condition of the metal panel needs to be examined which requires removal of the material.

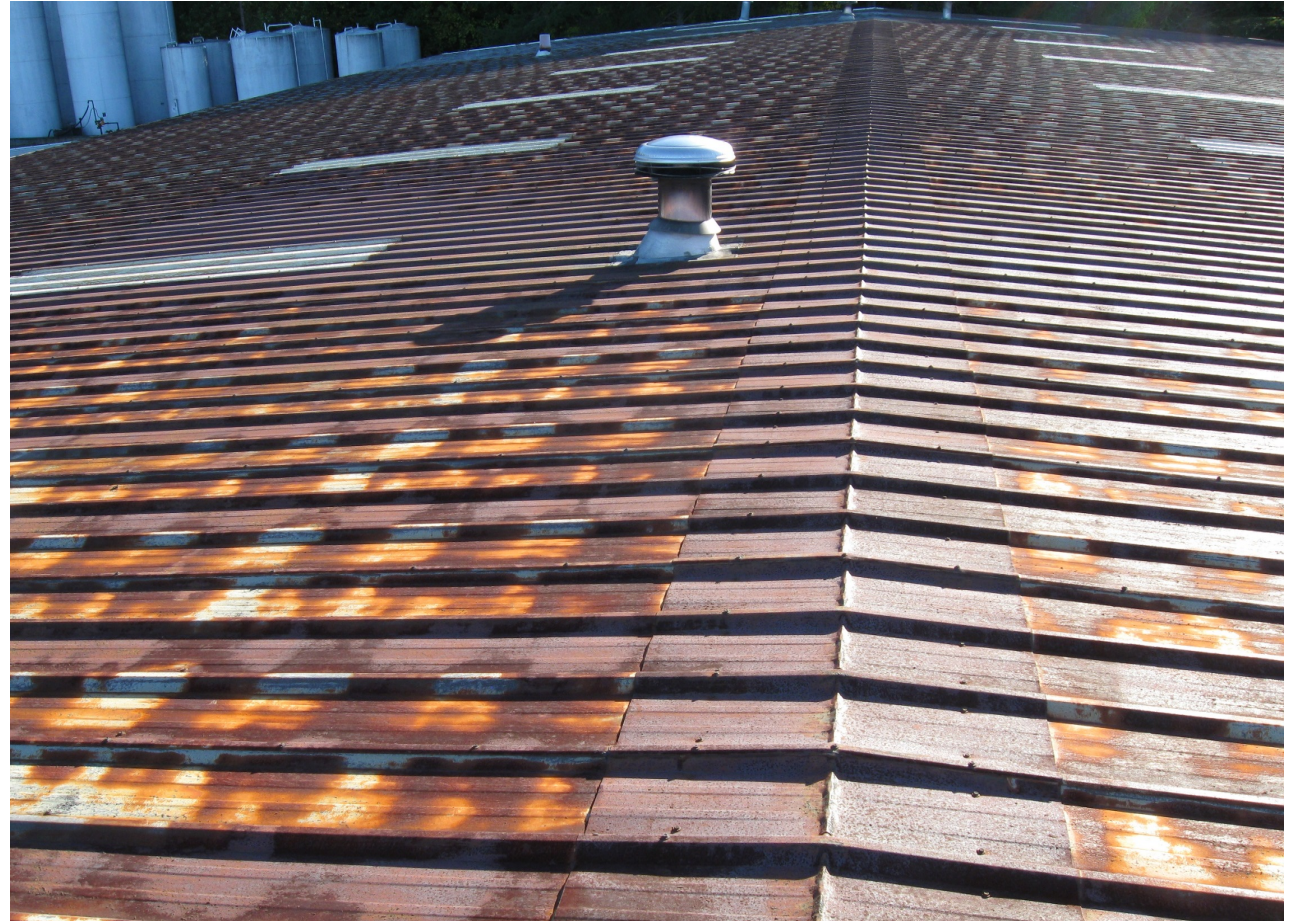
Corrosion Evaluation: once the metal has passed the test for structural soundness, it often exhibits a great deal of surface rust. This rust must be treated and removed before restoration can begin.

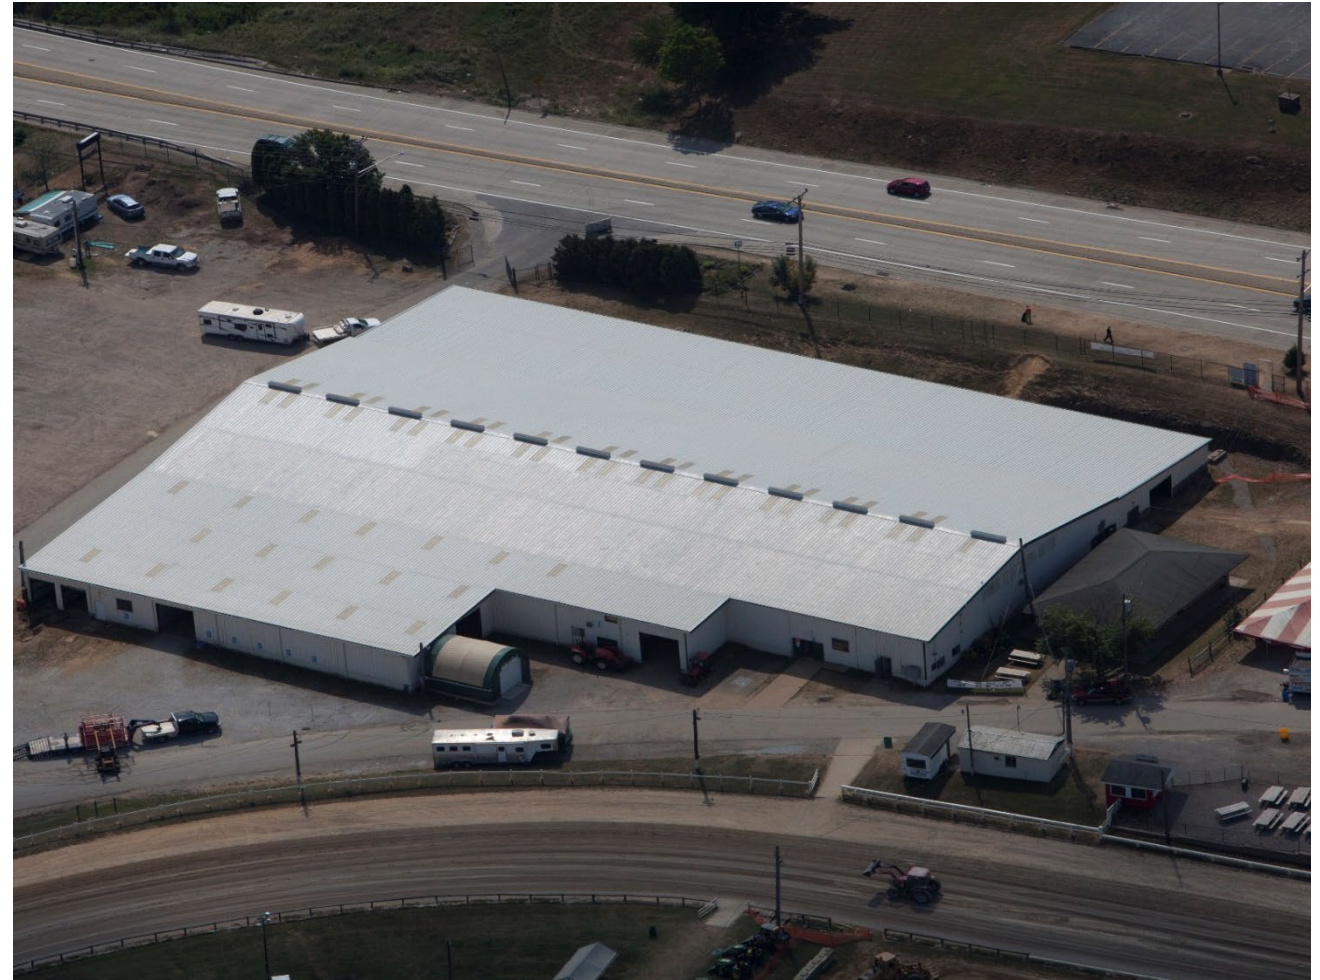
Metal Panel Partial Replacement On a Large Scale

When a metal roof has significant rust it normally starts at the horizontal seams

In this example, approximately 10% of the metal panels were replaced due to excessive corrosion.

The calculus to determine whether or not to use an engineered restoration coating or to retrofit the roof with new metal is often solely based upon the cost of metal panel replacement plus the coating versus new metal panels throughout.

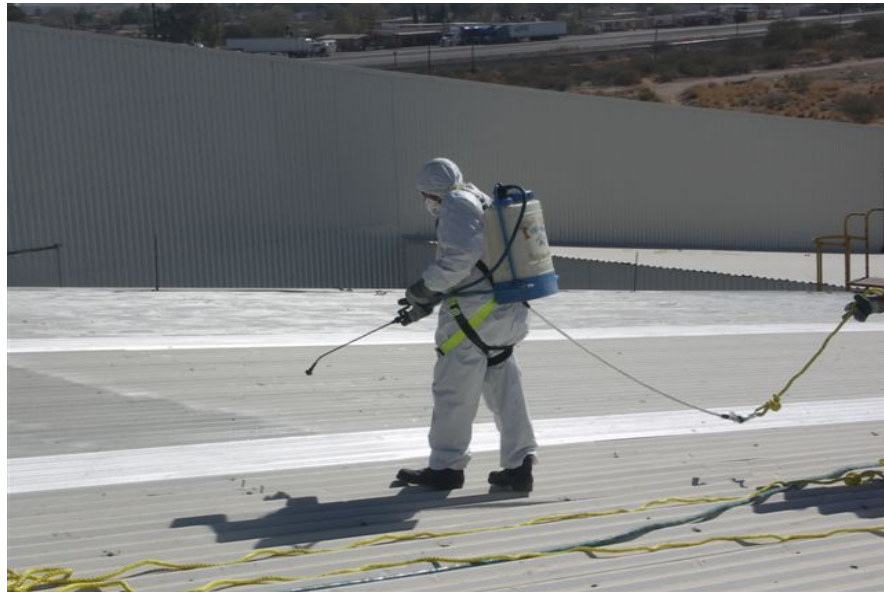
Rust remover and conditioner

Most rust removing agents are irritants so a breathing mask is recommended. A simple garden style pump is sufficient to spot apply material left in place for 12 hours.

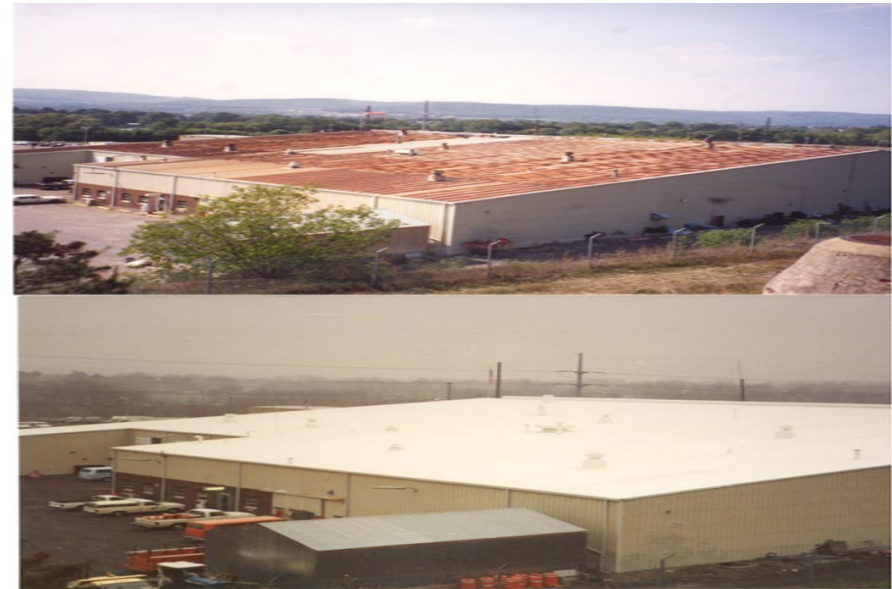
An important design consideration is to use a low perm/vapor barrier material to prevent moisture and oxygen from reaching the treated surface in the future. SEBS has extremely low permeance and therefore, would be the design consideration of choice specified with enough dry mils to create an impenetrable moisture barrier.

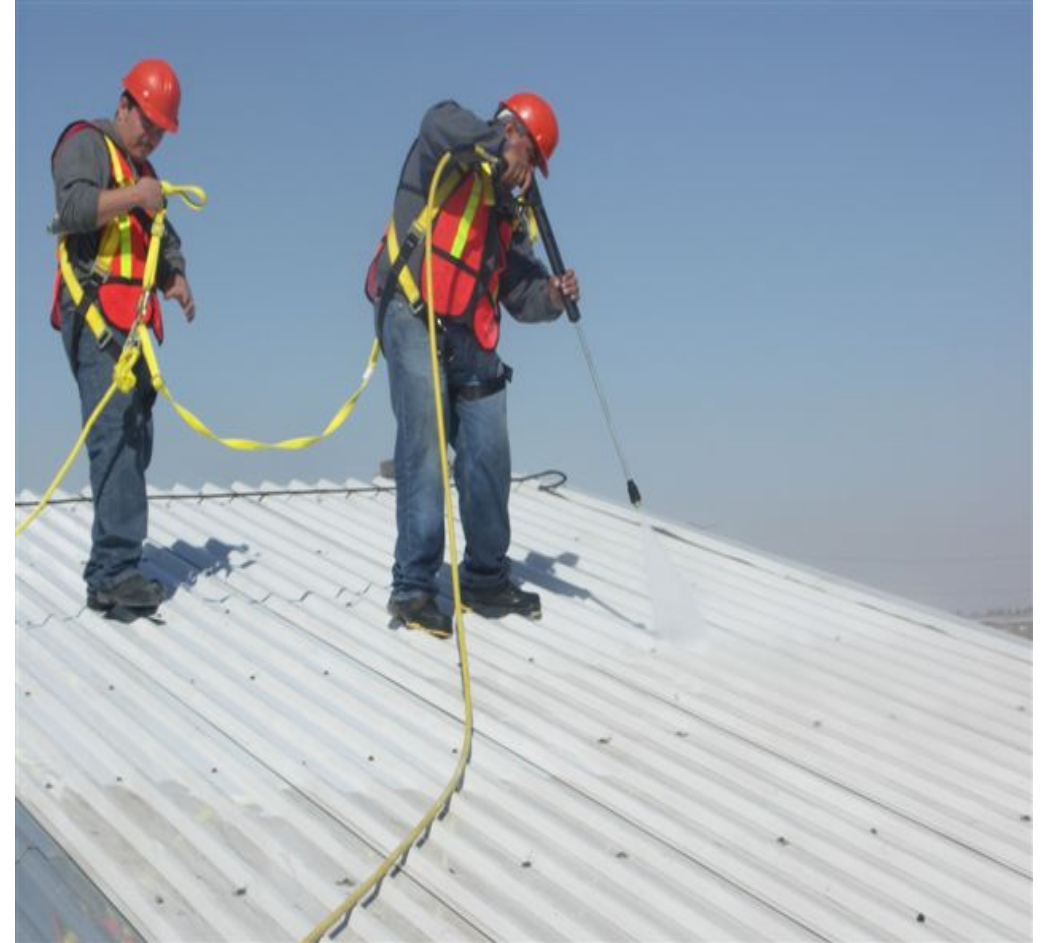
Power Washing with oscillating turbo tip

Often there are existing materials in place that must be removed to achieve minimum adhesion of new materials. The oscillating turbo tip removes most previously applied coatings.

*Helpful Tip - Large scale projects can be more cost effective using spray equipment. However, operators must watch dew point, temperature limitations, wind and wind direction

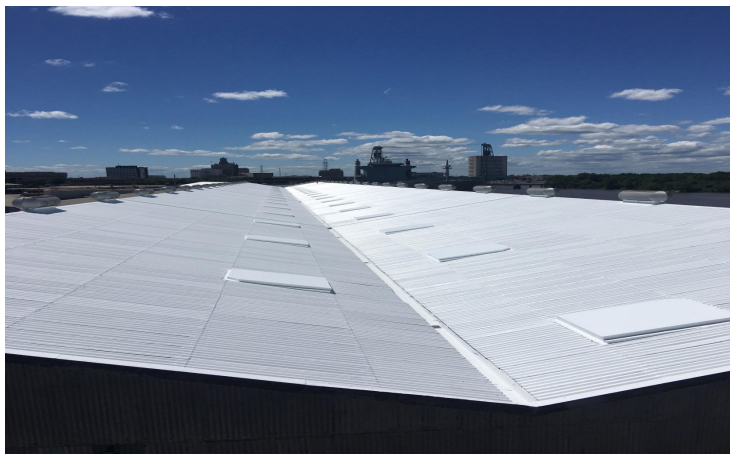
SEBS coating used on a large scale metal roofing used in warehousing

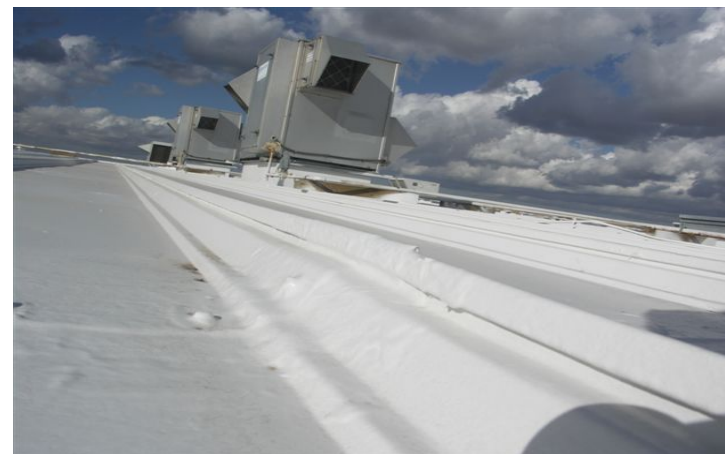
Energy Star Reflective Coatings: Significant kwh reduction for air conditioned facilities typically range 7-14%

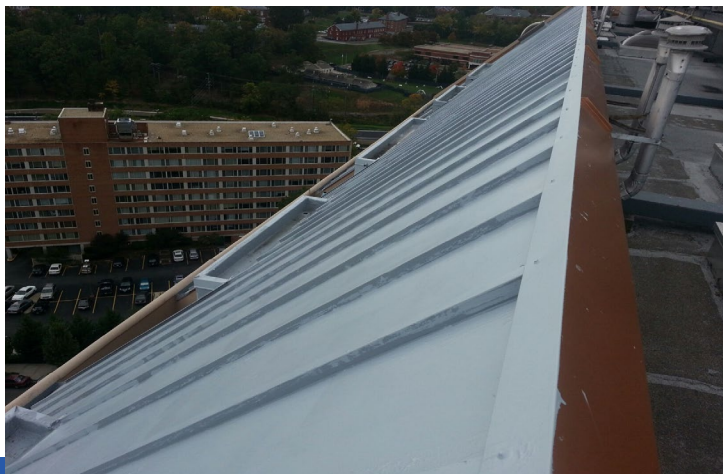
Steep slope on high rise construction offers difficult challenges, much higher labor and specialized tools to cope with difficult angels and slope. Range of colors often necessary to match cosmetic expectations.

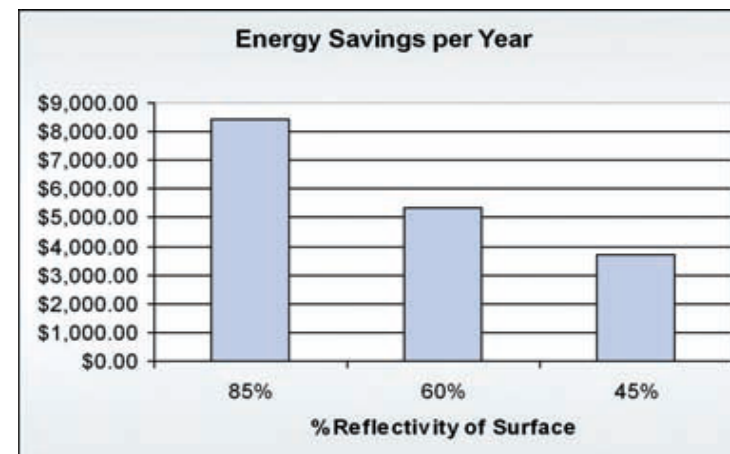
Savings estimate over EPDM 100,000ft² - Dallas, TX, assuming \$0.07/kwh

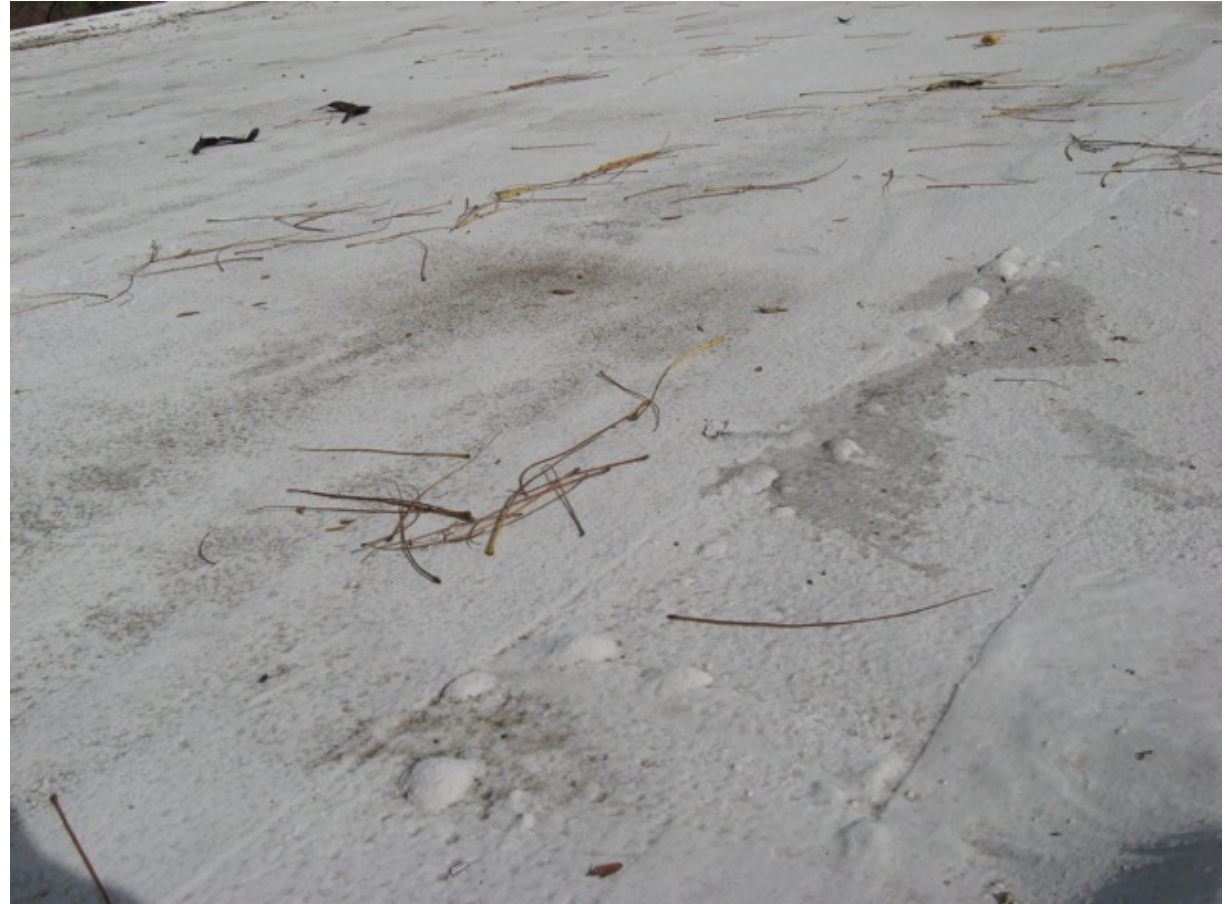
Moisture Entrapment

Low vapor permeance coatings trap existing moisture in restorations over low slope roofs. Removal of high areas of moisture concentration is required to minimize moisture entrapment post restoration

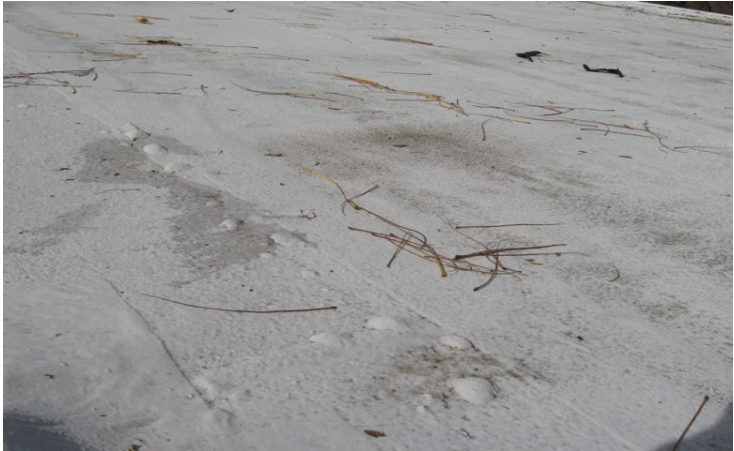
Moisture Entrapment: Low vapor permeance coatings trap existing moisture in restorations over low slope roofs. Removal of high areas of moisture concentration is required to minimize moisture entrapment after the fact of restoration

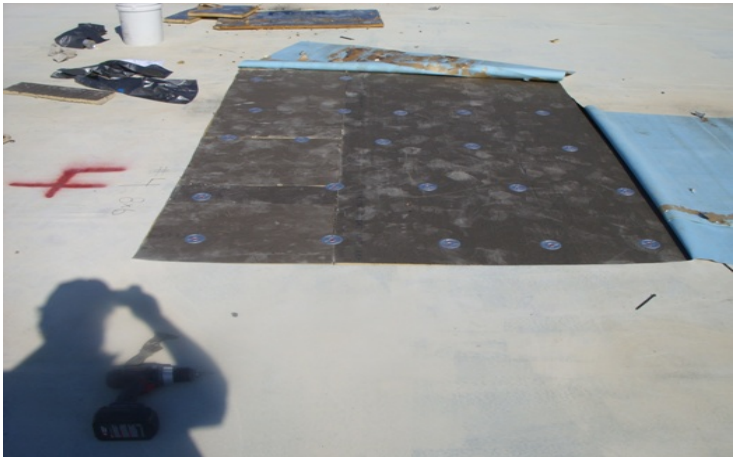
All saturated insulation is replaced with identical insulation material

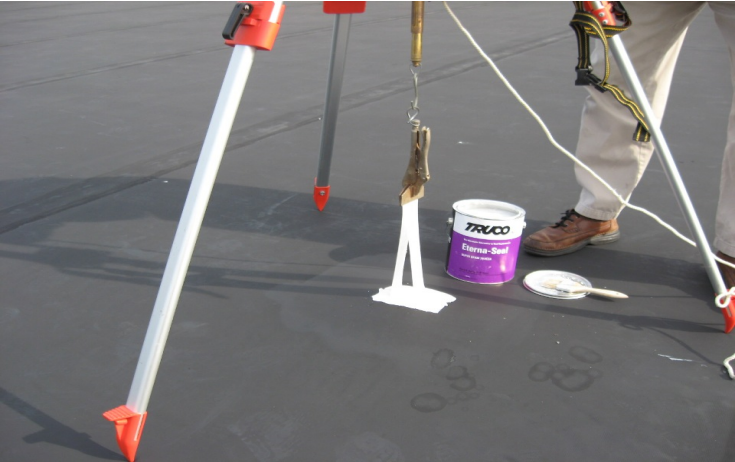
All substrates need to be evaluated for material compatibility and adhesion capability before proceeding with any design proposals.

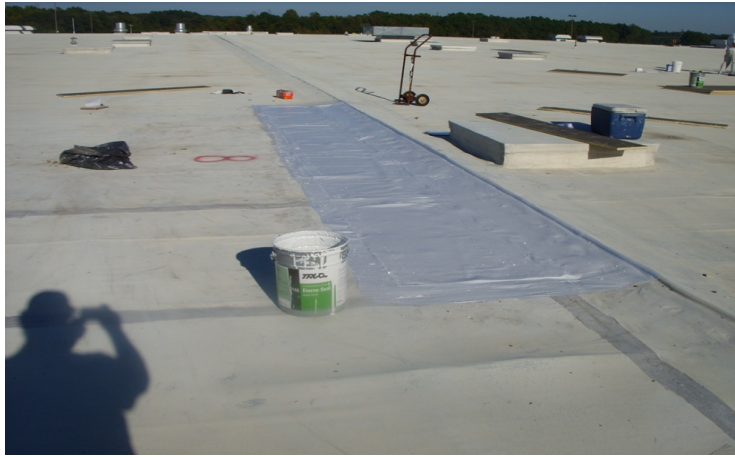
New insulation is covered with identical membrane to prevent capillarity and to apply seam free coating over entire roof area.

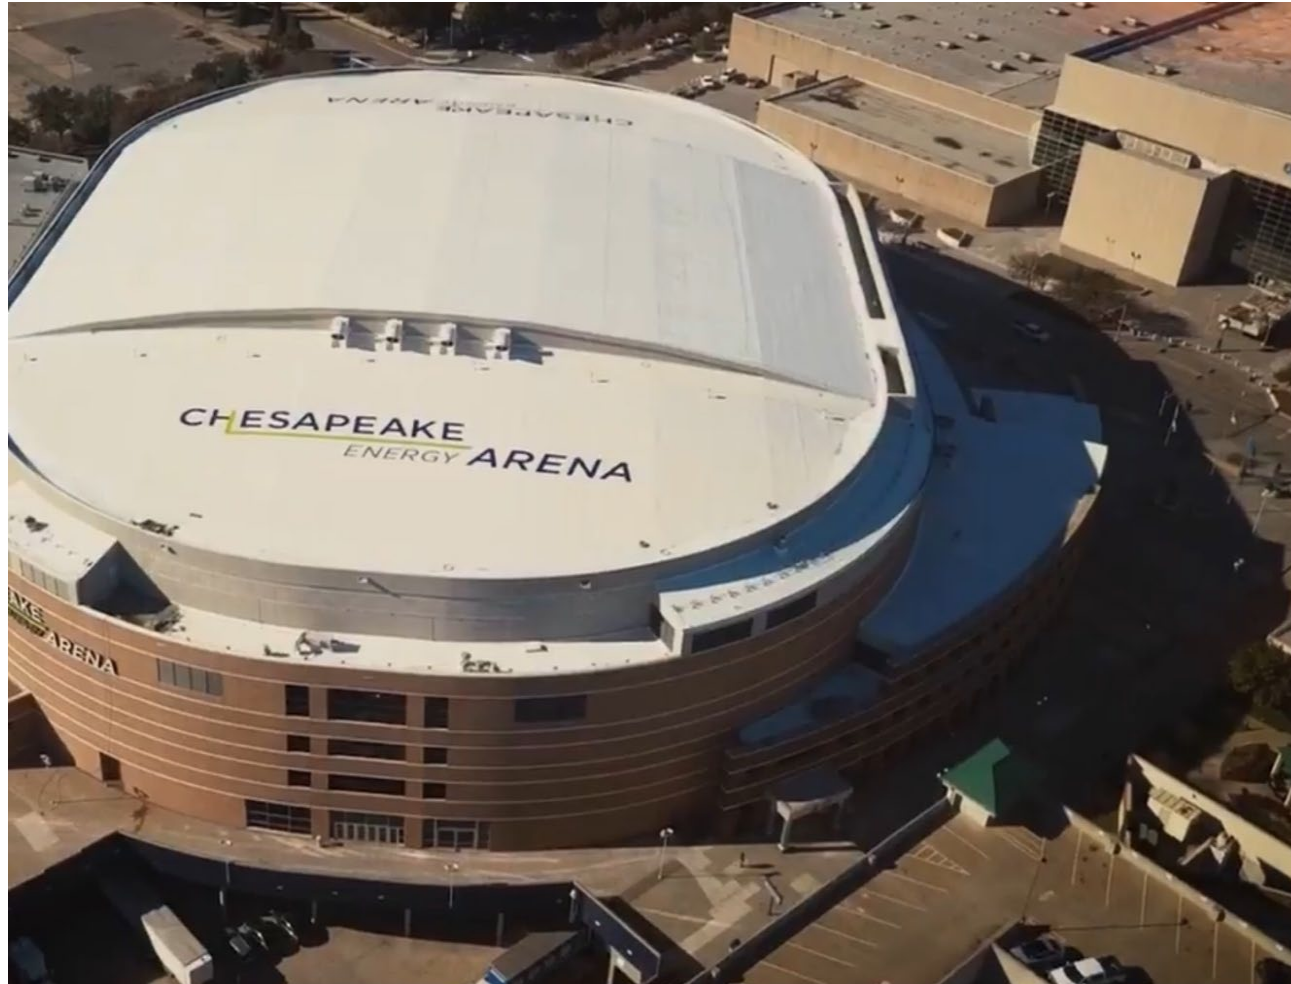
A full restoration of an SEBS Granulated Modified Bitumen

Weathering can lead to granule loss that can lead to an increase in heat and energy loss. The lack of granular protection accelerates the heat aging problem of MB's.

All voids must be repaired before any repair or restoration may begin.

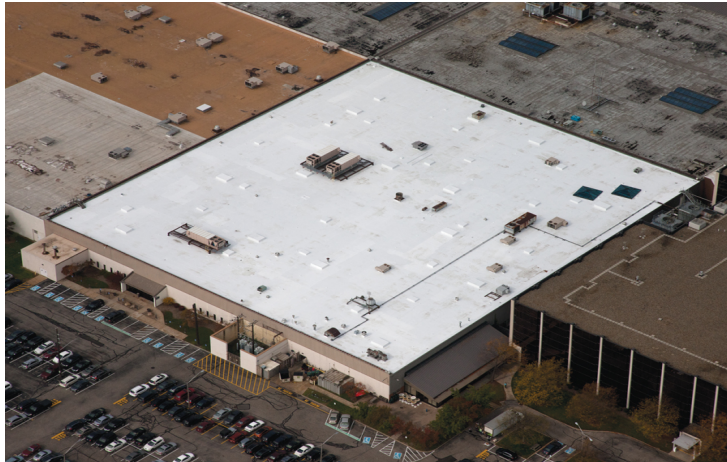
Factory with 300,000ft² of Hypalon Single Ply with a 20+ coating with perimeter bar straps to insure mechanical attachment integrity of system

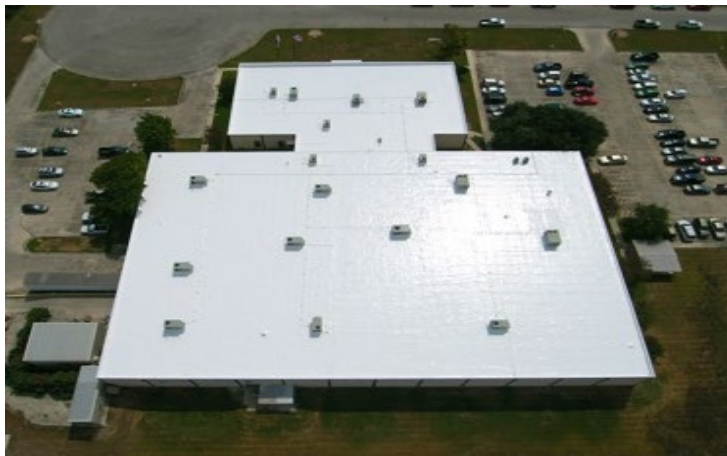
Engineered coating over Single Ply

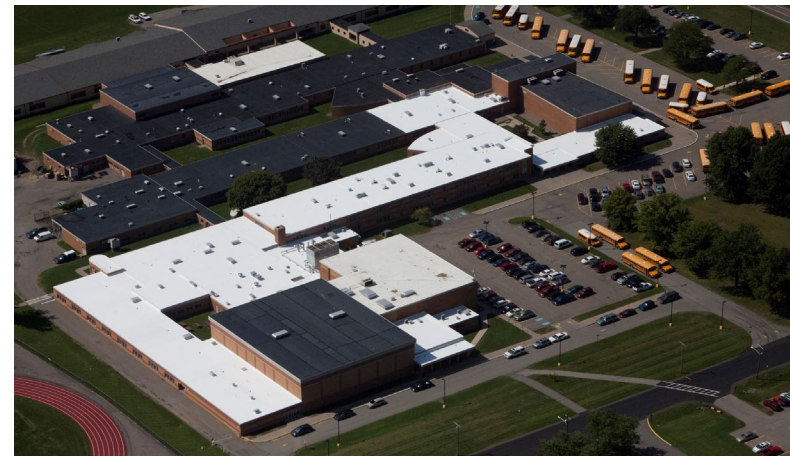
Fully adhered EPDM with an engineered coating progressively installed for continued protection and preservation of capital dollar expenditures for school systems

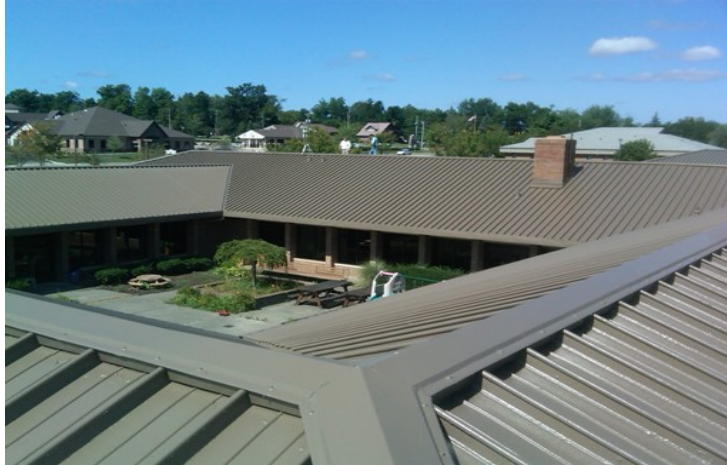
Careful and competent application yields great cosmetic results over metal roofing

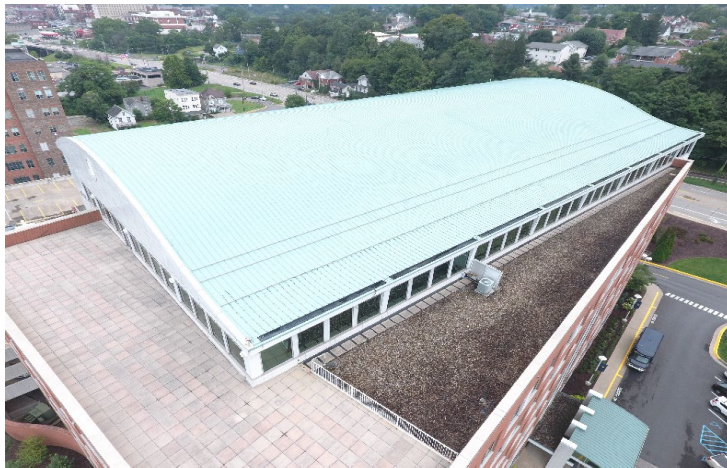
Specialty applications like this over faux copper coating over standing seams

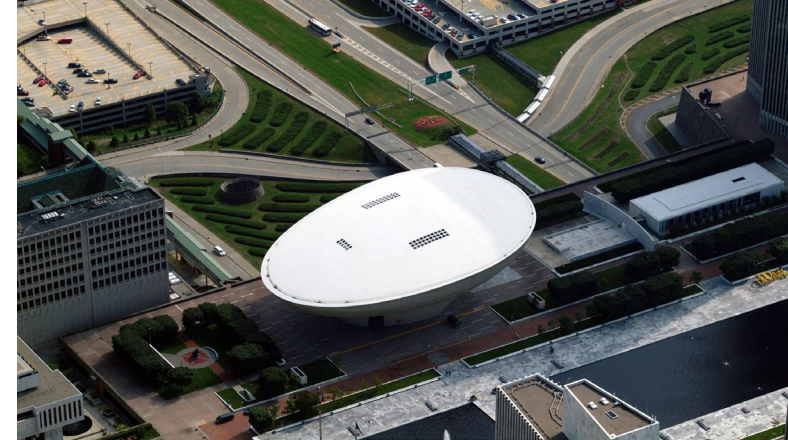
Irregular geometry with constant wind and difficult access can be overcome with expertise and careful planning

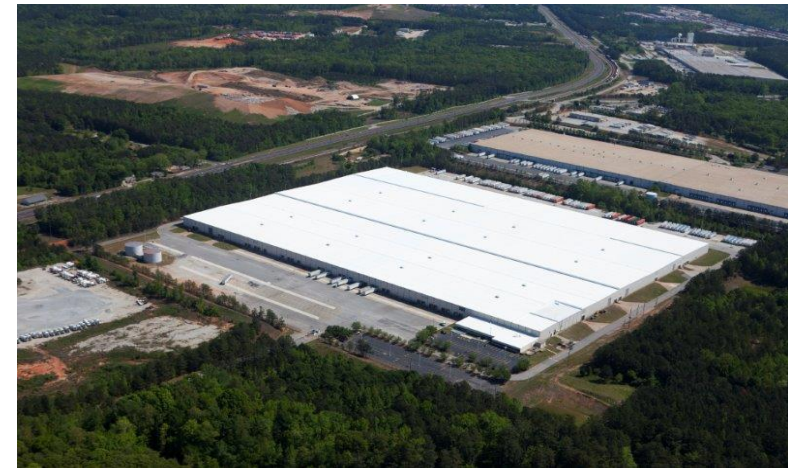
Distribution Center – 600,000ft² engineered coating over metal roofing

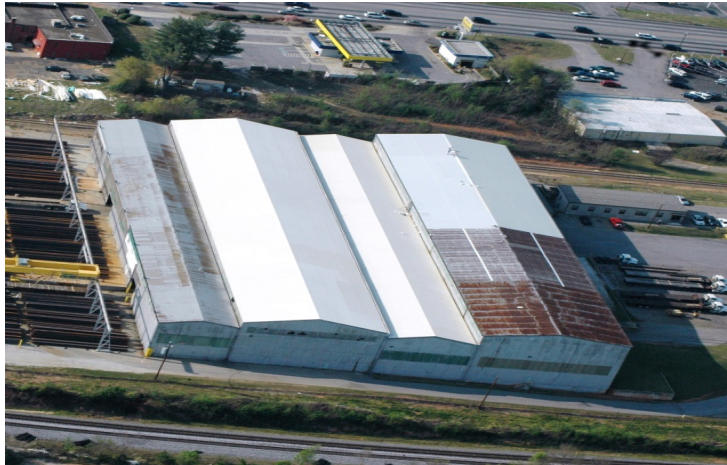
The progression from rust removal to a finished system

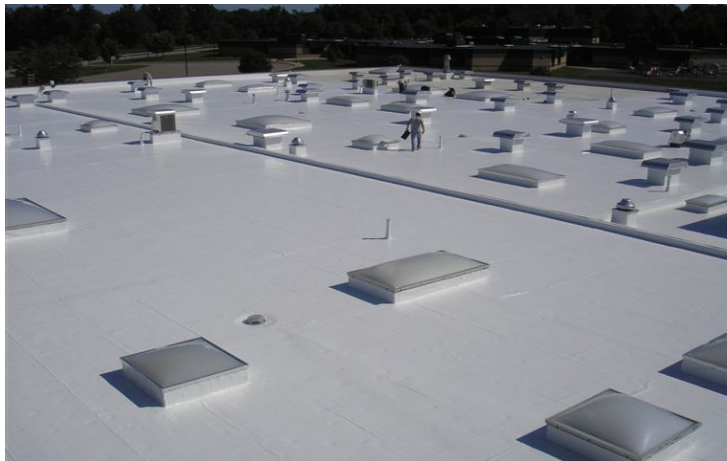
A White Finish: has the highest reflectivity but light gray is close in reflectivity and helps hide accumulations of dirt and stains from normal atmospheric contributions

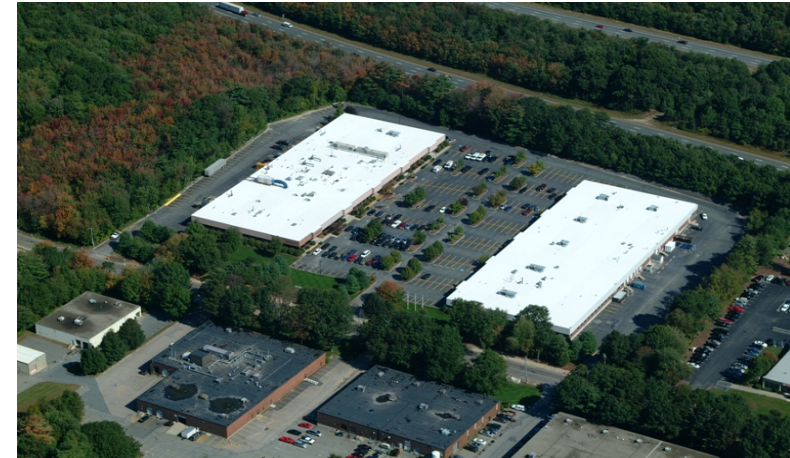
Hypalon weathering – 0.30 & 0.35mil thickness resurfaced to .50mils

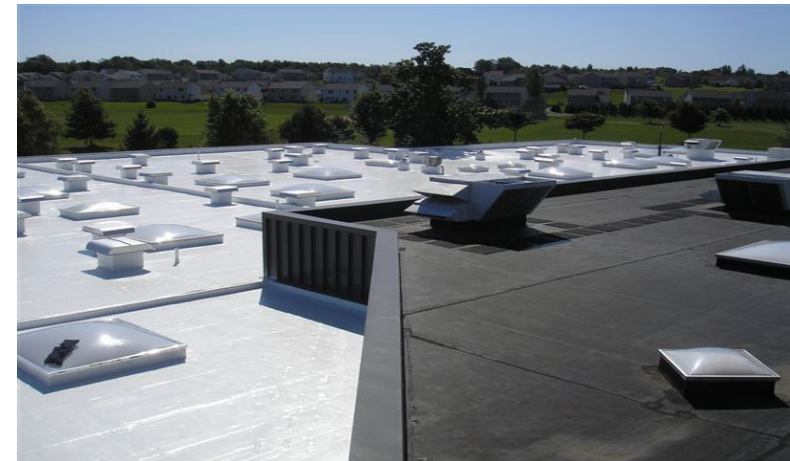
EPDM Restoration: resurfacing aged EPDM will provide high reflectivity and lower perm rating.
